Offshore coatings Why fail when you can succeed?

NEW PAPER ANALYSES HOW TO SAVE 'MILLIONS'

PROJECT A 'BAND OF BLISTERS' OFFSHORE WINDFARM

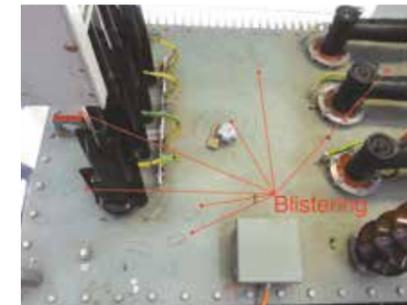
Blistering problems on circa 6m² of two substation transformer covers after two years at sea highlighted the difficulty of allowing small components subbed out and then subbed out again, to slip through the QA net. Original client specifications are easily lost or diluted down the supply chain.

In the first year offshore, white zinc-salt formation under a coating applied onto Thermal Sprayed Zinc (TSZ) caused blistering. Failure analysis revealed the ultimate coating-system not complying with ISO 12944, or the client's original specification.

In reality, a two-coat powder-coating-system of suspect quality was used on top of a poorly-applied TSZ. The originally specification required a five-coat liquid-applied coating-system - including a zinc-rich primer, two water-based intermediate coats, plus two water-based top coats.

Repair work while the 150,000 volt transformers were live in poor weather conditions, during complex transfer operations and with stringent offshore safety certification requirements, meant a final bill of up to ± €16.666/m²! All this could have been avoided... rather easily.

Remedial work cost circa €100,000. Investing a couple €-thousand in fully-trained, qualified and certified coating-inspectors before and during the original coating application would have avoided the whole problem. Specifically, the covers of two auxiliary transformers passed so far down the supply chain that although the coated area was minimal, specifications, procedures and quality-control were lost.

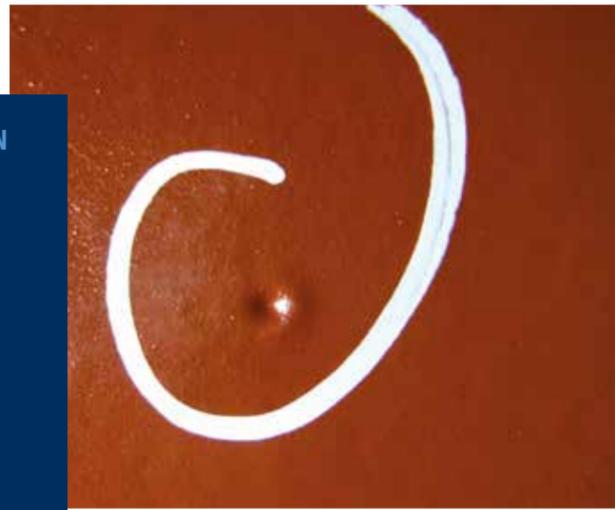
PROJECT B
'HIGH TENSION' OFFSHORE
WINDFARM

The problem persisted, resulting in an intensive search for possible contamination-sources. As QA for the main contractor, we insisted on further in-depth laboratory-analysis of production samples. Several high-tension, high-level meetings followed. Fortunately, a willingness on all sides to reconfigure the production & delivery-schedule meant that

Thousands of craters found in the first coat during fabrication of three (of 43) transition piece foundations resulted in €100,000+ worth of fabrication-shop re-blasting and re-painting work per transition piece. The alternative would have been an estimated €2.25 million bill if the problem was left to develop further offshore! Initial coating-manufacturer and coating-contractor reassurances that a limited problem could be remedied by an extra intermediate layer to compensate for local under-thicknesses proved wrong.

suspect coating-batches & transition-pieces were quarantined pending lab test-results. Careful analysis revealed the basic problem stemmed from an 8% silicon contaminant added in error to the coating. A full 'Norsok qualification lab-test cycle' then proved that one batch failed the Cathodic Disbonding test miserably. The coating-manufacturer ultimately concluded that the offshore coating-failure risks were too high. Reblasting/recoating was the only sensible solution.

A small side-issue - proper registration of coating-batch-numbers - also showed that non-qualified QC-staff use is "an accident waiting to happen". Unnecessary repair-costs could have been even higher. Full diligence from the outset could have prevented the whole problem. We helped save the contractor in excess of €2 million.

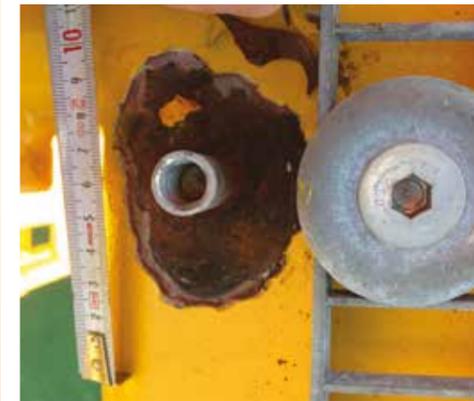
PROJECT C
'MINOR DETAIL – MAJOR PROBLEM'
OFFSHORE WINDFARM

Poor coating & QC practice on 5,400 overlooked stainless steel grating-studs on carbon steel structures for 30 out of 71 widely-dispersed offshore wind turbines turned a minor detail into a significant problem.

Most studs were not treated properly to Norsok M-501 standards; an average corroded area of 17cm² per stud, times 180 studs per foundation, times 30 foundations was the result. Offshore remediation costs mushroomed quickly to €1.5 million.

Two years after offshore-installations, ALL 30 Contractor B foundations showed corrosion-breakthrough around some

5,400 main platforms & resting-platforms grating-studs. Opening the coating showed substantial areas of surrounding carbon steel corroding due to 'galvanic corrosion'. Clearly, these studs and especially the 'mixed weld', had not been treated to Norsok M-501 standards. Coating-thickness on the studs was less than required. Masking-tape was found under paint. Some surface-profiles were poor.

Full QA/QC control could have prevented a minor infringement becoming a major calamity from the start.
